Appendix

Waller Creek Corridor Framework Plan

TABLE OF CONTENTS

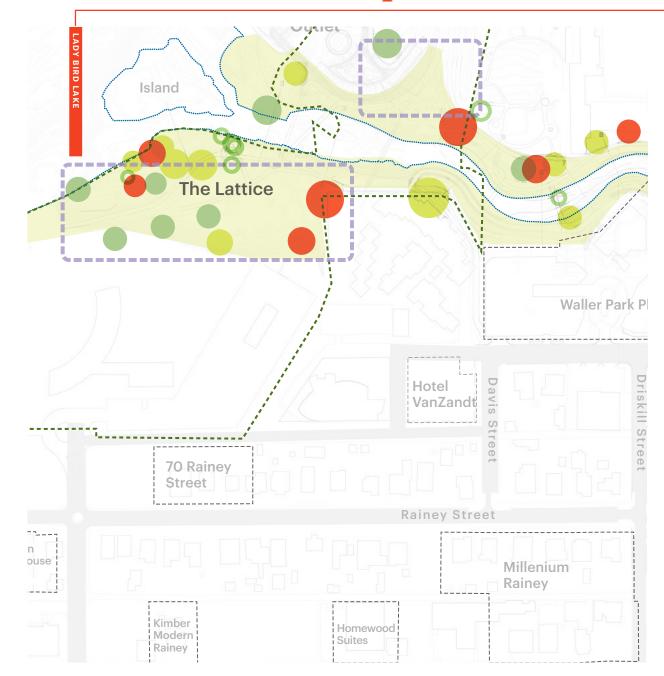
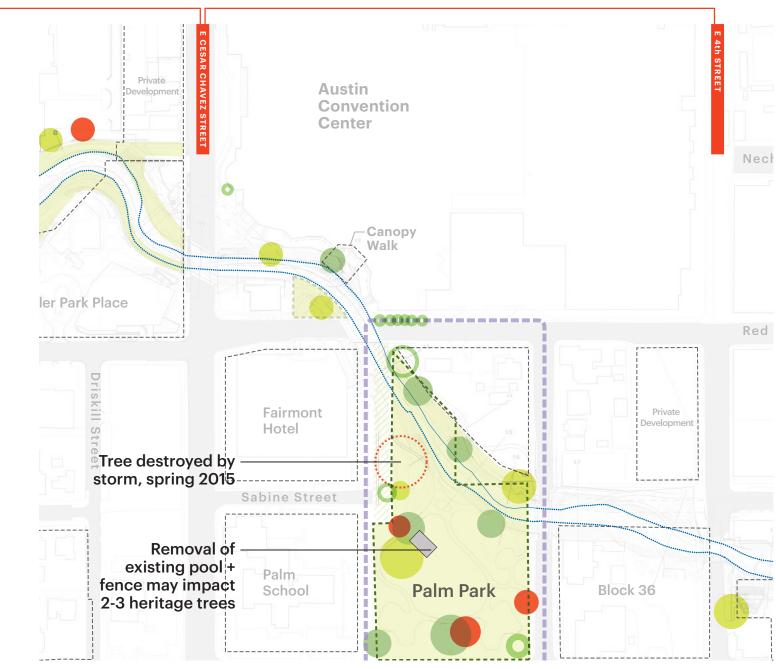
Heritage Trees Site Map HERITAGE_300sc.pdf

SOURCE: 2012-2013 ArborPro survey & 2014 dwg graphic conversion. Evaluation based upon an adaptation of the Council of Tree and Landscape Appraisers (CTLA) tree appraisal standards (CTLA, 2000 Guide for Plant Appraisal, 9th Ed.)

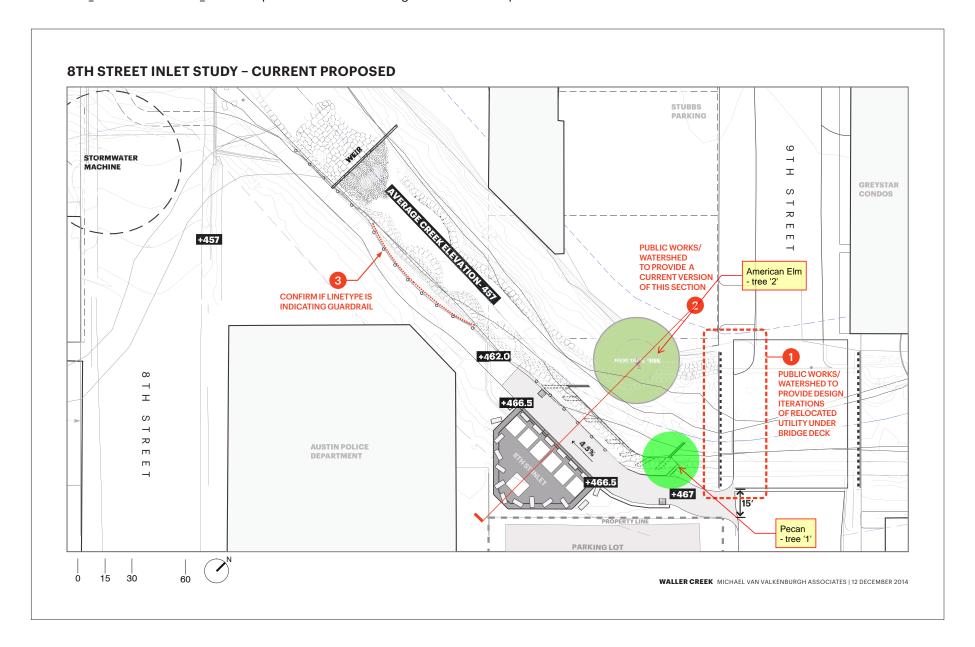
8th Street Inlet Study (1-2)

Pecan - Tree '1'
- Unknow caliper size.
- Undocumented assessment in 2013 CBD Tree Inventory

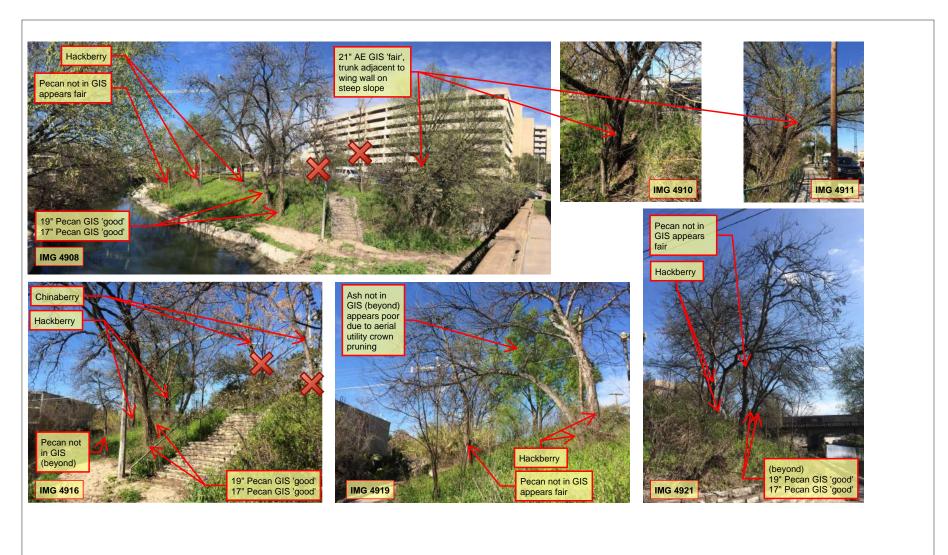
WC CORRIDOR FRAMEWORK_Waterloo Trees Park 2 of 4

23" LO GIS 'fair'

LO not in GIS, appears good

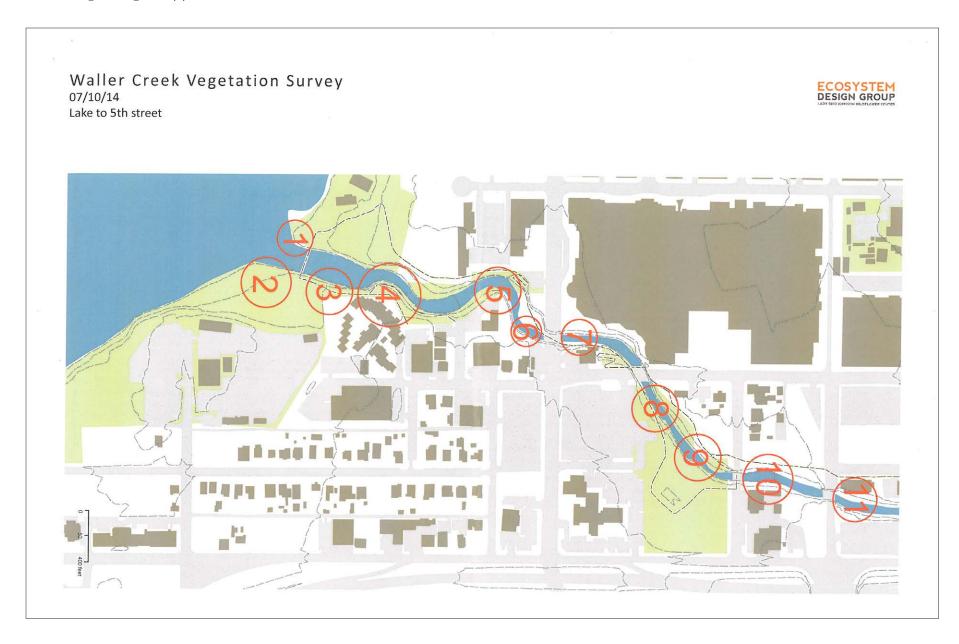
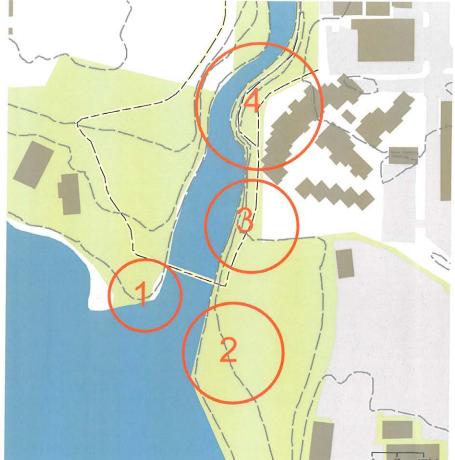
Waller Creek Vegetation Survey (1-2) 2014.07.29_LBJWC_Survey.pdf

1. Overstory -80-100% cover - dominant: black willow, hackberry

2. Overstory - cover - dominant species: black willow, hackberry

3. Overstory - cover - dominant: hackberry

4. Overstory - 75-100% cover - dominant: hackberry

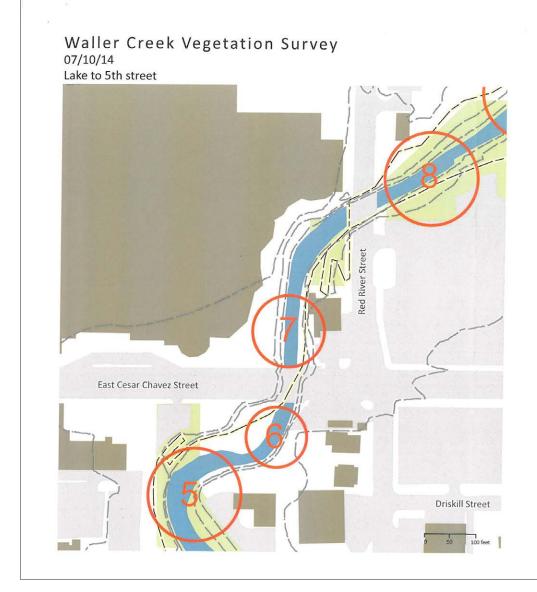
Waller Creek Vegetation Survey (3-4) 2014.07.29_LBJWC_Survey.pdf

- 5. Overstory 75% cover dominant: American elm
 - -cottonwood, box elder, chinaberry, golden rain tree, huisache, sycamore
 - Midstory % cover dominant: young bald cypress
 - chinaberry, Japanese ligustrum, huisache, golden rain tree, alianthus?
 - Groundcover <10% cover dominant: poison ivy
 - -giant reed on west bank

Notes: on rock wall : river fern, holly fern, maidenhair fern, golden rain tree abundant. block wall threatened by trees growing between blocks. creek bed has Britton's wild petunia and dallis grass, green ash, giant ragweed.

- 6. Overstory % cover dominant: willow, chinaberry, pecan
 - -hackberry, american elm, sycamore, box elder, ligustrum

- 7. Overstory % cover dominant: chinaberry
 - -golden rain tree, American elm, golden rain tree, ligustrum, mulberry

- 8. Overstory 60-70% cover dominant:
 - -pecan, American elm, walnut, hackberry, chinaberry
